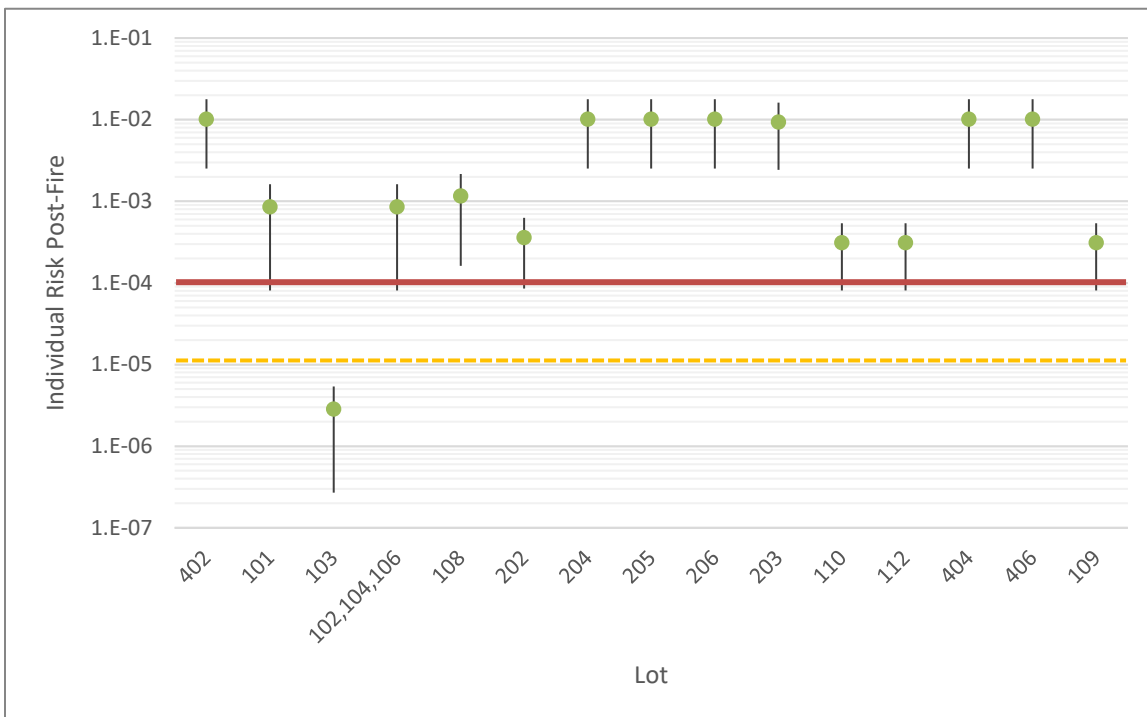
Figure 4-8. Post-fire PDI for lots in the evacuation zone assuming full-time occupancy. Solid red and dashed orange lines are the District of North Vancouver and Town of Canmore PDI thresholds for existing and new developments, respectively.

The same twelve dwellings remain in excess of the 10^{-4} criteria if post-fire P_H is increased only fivefold. BGC repeated the risk assessment assuming full-time occupancy in all dwellings to provide context for long-term land-use and policy development (Figure 4-7 and Figure 4-8).

The analysis was repeated with the assumption of full-time residency of all habitable buildings. In that case, the pre-fire risk would be similar to the current occupancy levels with ten properties exceeding the 1:10,000 life loss risk criterion. For the post-fire situation fourteen evacuated properties would exceed the 1:10,000 life loss risk criterion. Of these properties, eight exceed 1:1,000 annual risk of loss of life.

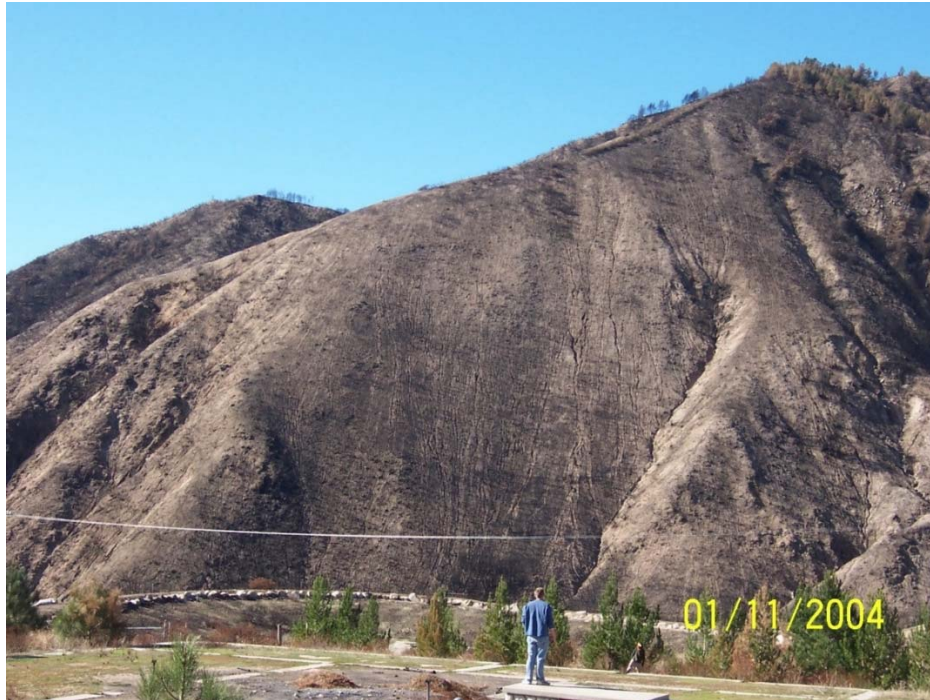
Figure A-1. Steep hillslopes and channels in the San Bernardino Mountains of southern California demonstrate how recently burned areas are prone to erosion following fire. Photo: Susan Cannon, USGS.

A range of erosive processes are possible in burned areas due to rainfall. Rills are small channels (less than 20 cm wide and 30 cm deep) that may erode hillslope material (Figure A-1). Progressive bulking of sediment (Cannon et al., 2003) in channels may form debris flows that can transport large volumes of material (greater than about 1000 m³), impart force sufficient to scar or snap trees (Figure A-2), and deposit enough material to bury cars, homes and roads. Debris-flow material deposited in flooded creeks with larger contributing drainage areas can result in debris floods that are highly erosive and capable of transporting significant volumes of sediment and woody debris (Figure A-3). These erosive responses of a burned area to rainfall may be the result of relatively normal rainfall events with frequent recurrence intervals (Cannon et al., 2008).

Geohazards are exacerbated by hydrologic changes to the burned watersheds. The removal of vegetative canopy, understory, litter and duff results in less attenuation of water during a rainfall event that is a result of fewer obstructions to flow and reduced evapotranspiration. As a result of the fire, more rainfall is able to concentrate in creeks at a faster rate and rainstorms can produce higher peak flows in creeks than before the fire. Furthermore, overland flow of water, which would normally infiltrate the soil, can cause excessive erosion of hillslopes and rocky terrain where overland flow of water is not common (e.g. rilling on hillslopes visible in Figure A-1).

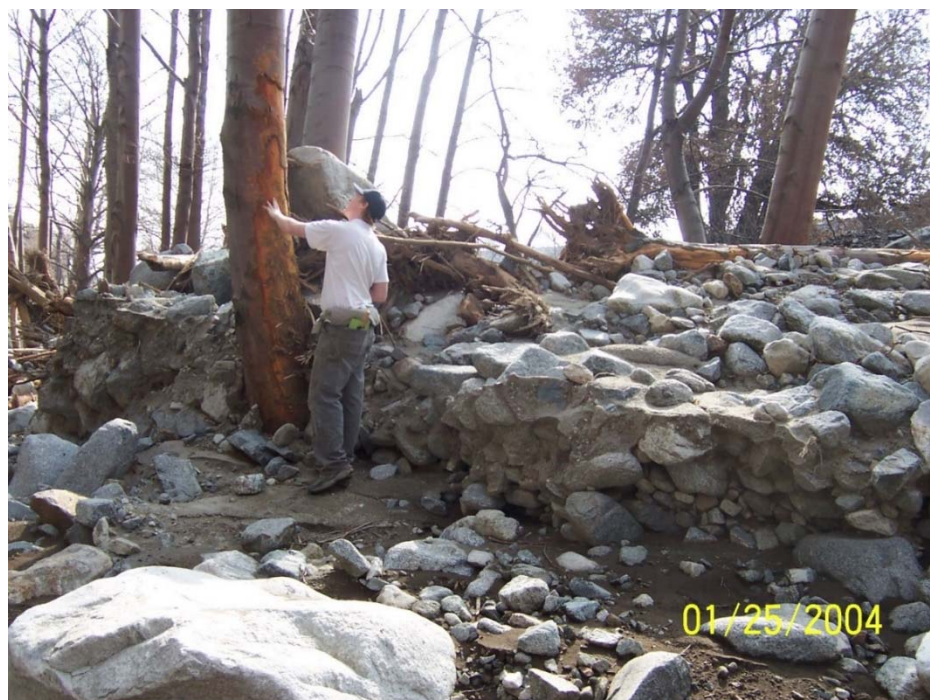
Figure A-2. A debris-flow deposit in Day Canyon, California consisting of large boulders embedded in a fine-grained matrix that scarred and broke full grown trees. Photo: Susan Cannon, USGS.

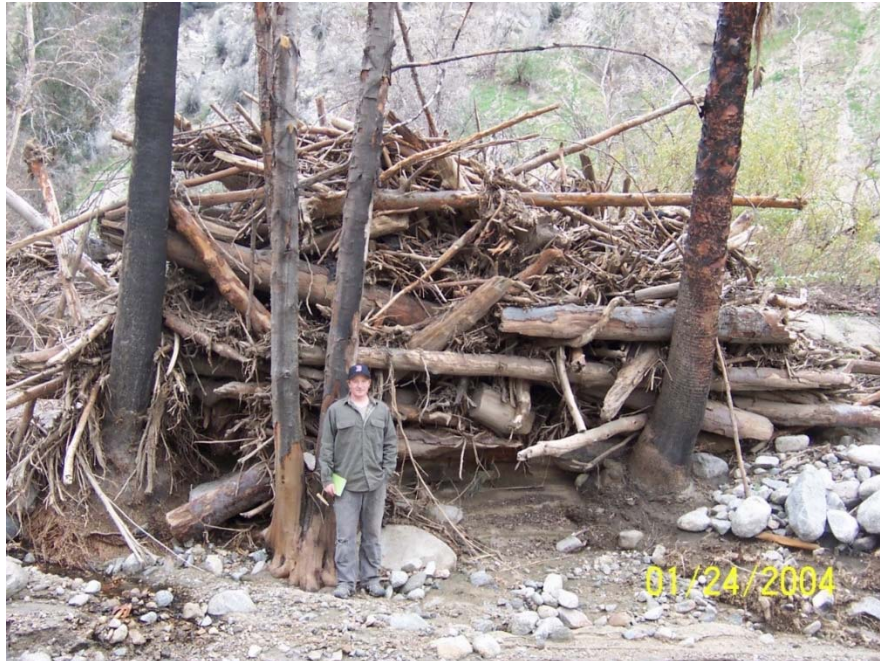
Figure A-3. Woody debris deposited by a debris flood in the San Bernardino Mountains, southern California. Photo: Susan Cannon, USGS.
